Operation UPSHOT-KNOTHOLE

March - June 1953

Project 3.5

TESTS ON THE RESPONSE OF WALL AND ROOF
PANELS AND THE TRANSMISSION OF LOAD
TO SUPPORTING STRUCTURE

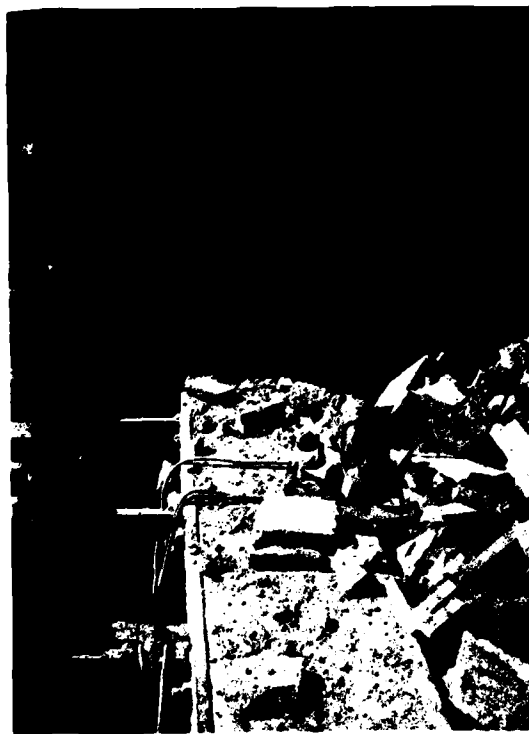
Fig. 4.13 Postshot, 3.5bd, Edge Blocks Showing
Crushing Failure

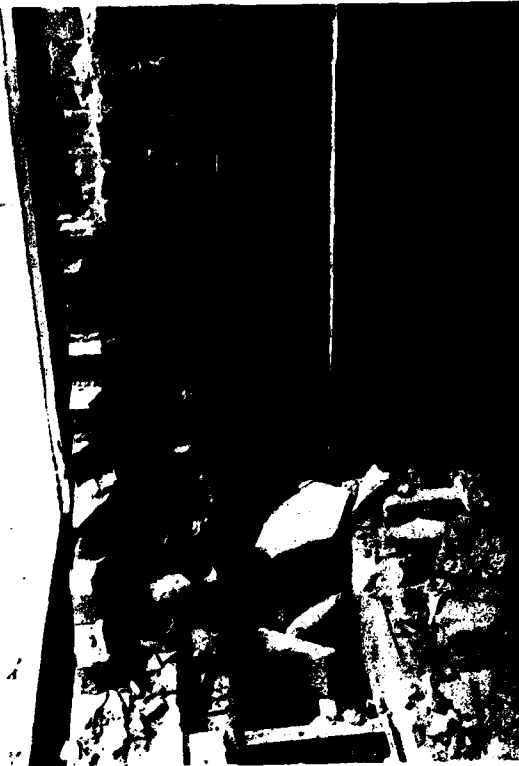
Fig. 4.15 Postshot, 3.5cc, Edge Brick and Block Showing Crushing Failure

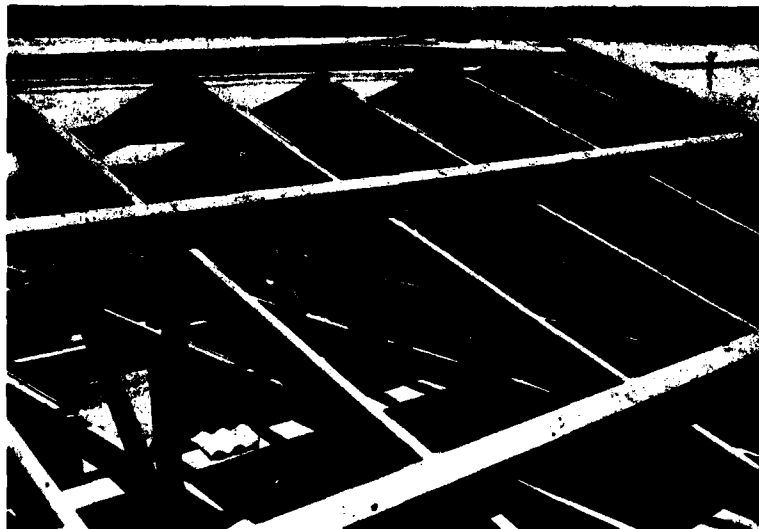
Fig. 4.18 Postshot, 3.5aa, Damaged Corrugated Asbestos Board Roof Panel (Note damage to top purlin and to top chord of trusses)

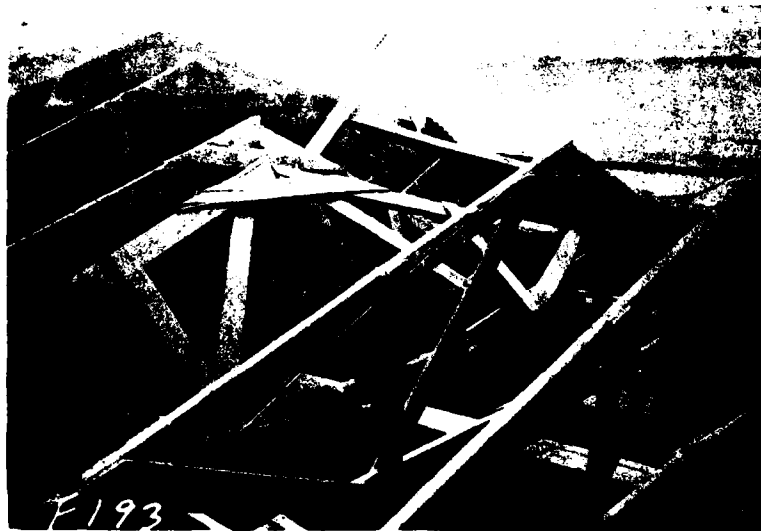
Fig. 4.20 Postshot, 3.5ab, Damaged Corrugated Steel Roof Panel (Note greater damage to trusses and purlins as compared to 3.5aa, Fig. 4.18)
